USDA FOREST SERVICE
RESEARCH PAPER INT-97
1971

INVESTIGATION OF SLOPE FAILURES IN THE IDAHO BATHOLITH

M. J. Gonsior and R. B. Gardner

INTERMOUNTAIN FOREST AND RANGE EXPERIMENT STATION
Ogden, Utah 84401

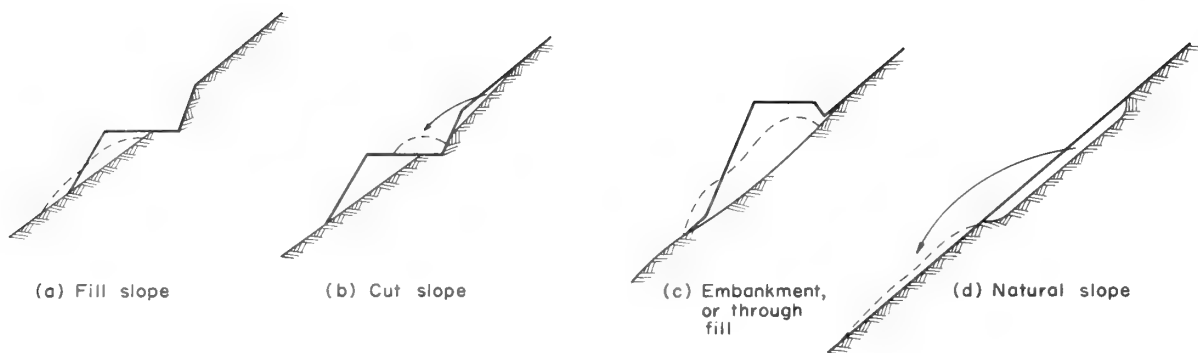
Figure 5.--Failure types.

A preliminary reconnaissance of the Zena Creek study area was made in May of 1967 to identify the extent and types of failures that occurred during the previously discussed 1965 storm event. As a convenience for analysis and discussion, four general failure types were identified, as shown in figure 5.

Based upon the preliminary reconnaissance, eight sites representing the three failure types shown in figure 5(a), (b), and (d) were selected for intensive study (i.e., fill-, cut-, and natural-slope failures, respectively). None of the embankment failures (c) were deemed amenable to analysis, but one stable embankment was selected for sampling and analysis. In addition, four other sampling sites were chosen for analysis of material properties representative of alluvial and bank slough deposits. All 13 sites are identified and briefly described in figure 4 and table 1.

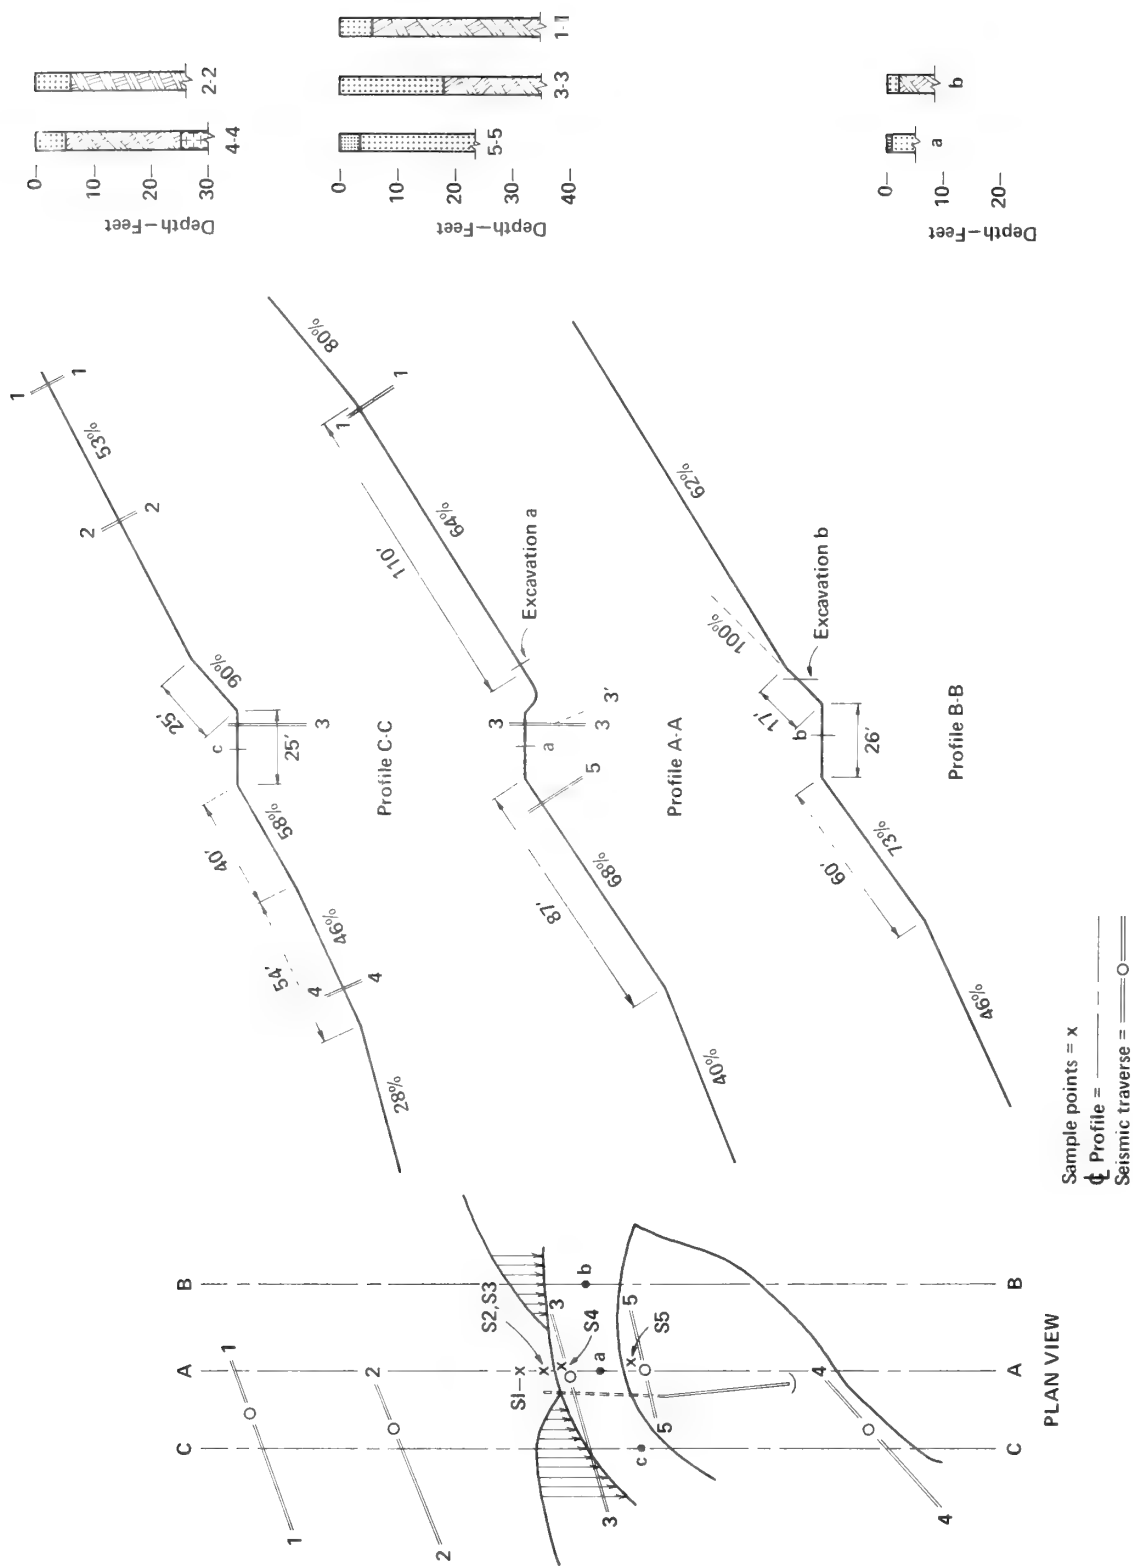
Figure 15.--Description of test site 917-1.

Site 917-1. As shown in figures 13 and 14, this site is a stable embankment crossing a small gully on Road 917 and is located approximately 1.7 miles from the junction of Road 917 and the main Secesh Road (fig. 4). A plan view and three profiles are shown in figure 15.

Five seismic traverses were run at site 917-1; the approximate locations are shown in figure 15. The small circles on the double lines represent the approximate locations at which the seismic interpretations are valid. Following are the interpretations, with the accompanying seismic velocities included:

Also shown in figure 15 are the approximate test pit locations.

Lines A-A, B-B, and C-C in the figure are the locations of the profiles sketched adjacent to the plan view in figure 15.

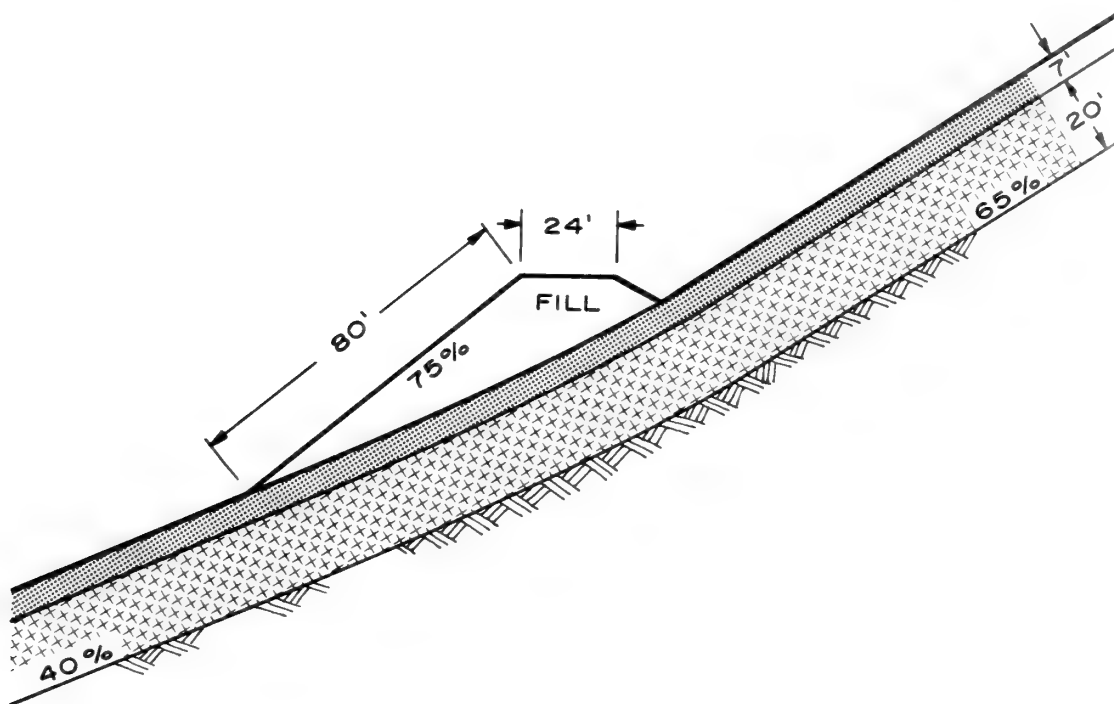
Figure 16.--Representative profile, site 917-1.

Based upon the data available, a representative profile of this site is shown in figure 16.

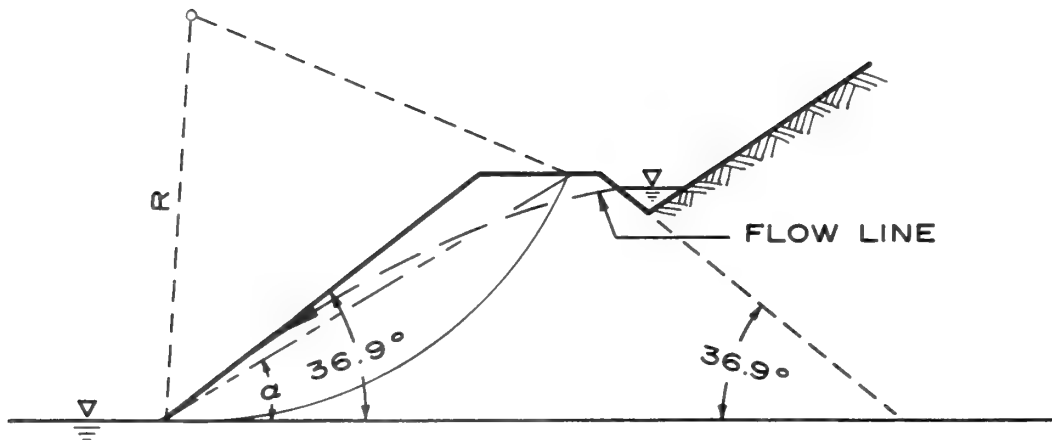
Figure 17.--Assumed conditions for L. Casagrande solution at site 917-1.

A conservative analysis can be performed by assuming a plugged culvert and subsurface flow as shown in figure 12. In this analysis, the L. Casagrande solution for the top flow line through a triangular dam is used² (see Taylor, p. 181). It is arbitrarily assumed that the upstream and downstream slopes of the dam are equal. Figure 17 depicts the assumed cross section.

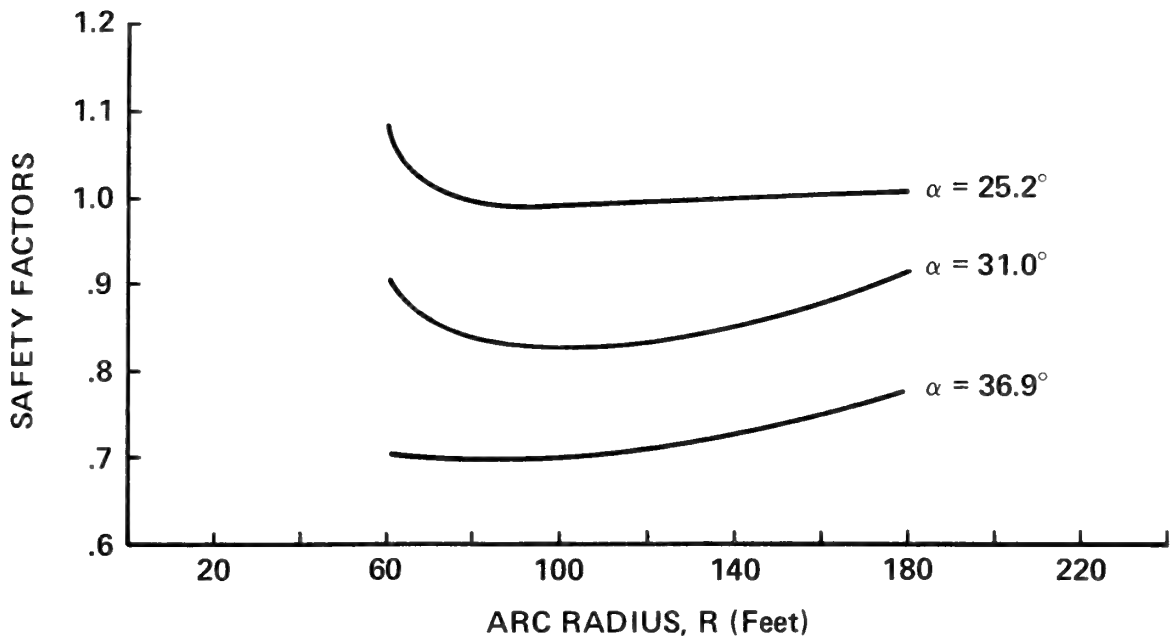
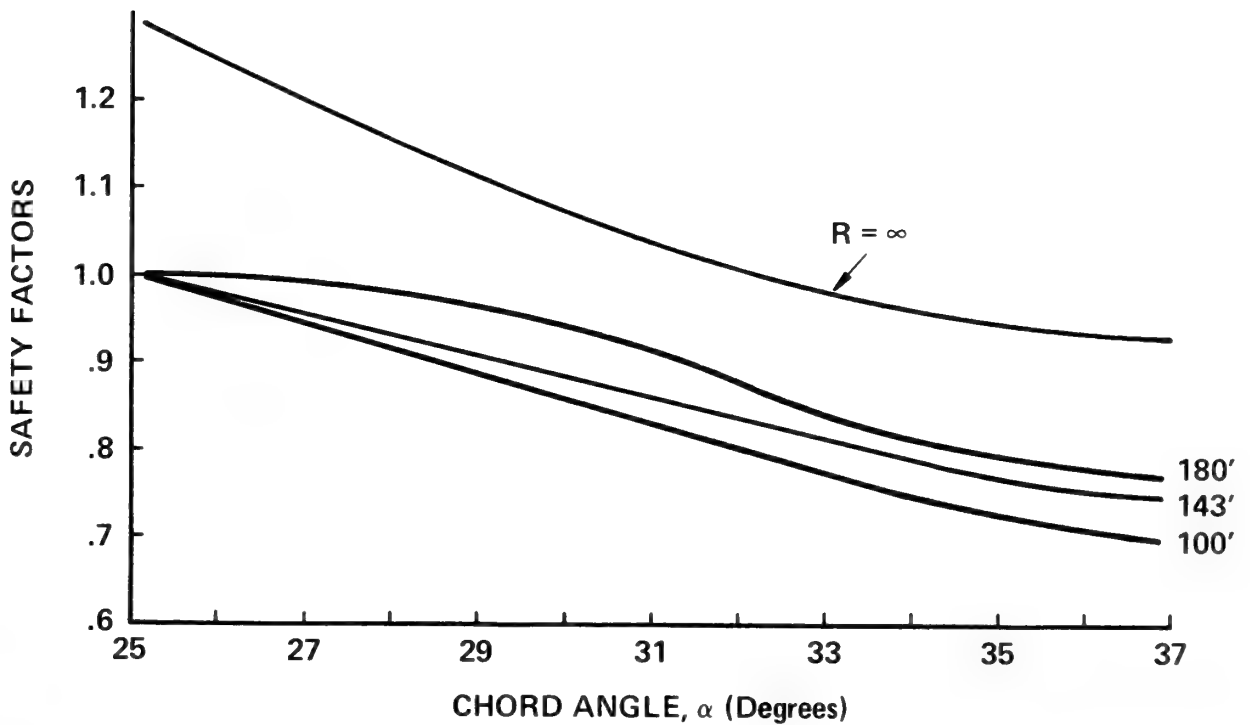
A series of analyses were conducted, assuming circular failure arcs and using the method of slices. In all cases, failure arcs were assumed to pass through the toe of the fill slope. The material above the top flow line was assumed to weigh the same as that below the top flow line, or 134 p.c.f. The results of these analyses, assuming that $c = 0$ and $\phi = 35^\circ$, are shown in figure 18 and, alternatively, in figure 19, wherein the parameters R and α are as shown in figure 17. Safety factors significantly lower than 1.0 are noted in figures 18 and 19. Three major conclusions can be drawn from these analyses:

- (1) The assumed friction angle of 35° may be too low.
- (2) The material actually possesses a minimum cohesive strength, even when saturated.
- (3) The assumed seepage conditions are significantly more severe than would ever arise naturally.

Figure 18.--Safety factors vs. arc radius, R , for conditions given in figure 17.

Figure 19.--Safety factors vs. arc chord angle, α , for conditions given in figure 17.

Although the effective friction angle in the field may exceed 35° , it is believed that the angle stated in the first conclusion is a reasonable estimate based upon the consistency of the laboratory results. Further, where the safety factors are as low as 0.7, a friction angle of 45° would be necessary in the absence of cohesion to increase the safety factor to 1.0. It seems inconceivable that the estimate of the friction angle would be this much in error.

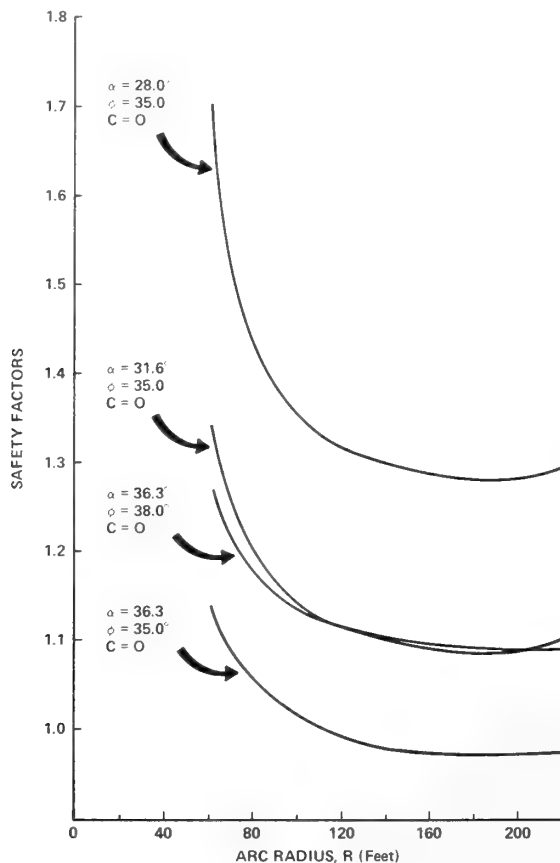
Figure 20.--Safety factors vs. arc radius, R , without seepage for site 917-1.

The third conclusion is undoubtedly correct. There is no evidence that the culvert has ever become plugged at site 917-1. Even in the event of such an occurrence, it is doubtful that a stable seepage condition as severe as that assumed in these analyses would arise. However, since the exact flow pattern cannot be predicted, a series of analyses were conducted assuming no seepage. This was done in order to establish a minimum upper limit for the safety factors at this site. The results of these analyses are shown in figure 20, where the parameters R and α are as defined in figure 17.

Again, it is noted that either the friction angle (ϕ) or cohesion (c) has been underestimated, since safety factors less than 1.0 were calculated. In these analyses, an estimated cohesive strength of 1.0 p.s.i., or 144 p.s.f., would have resulted in a minimum computed safety factor of approximately 1.4.

To evaluate the influence of error in the estimate of ϕ , a series of analyses, again assuming no seepage, were conducted with $\phi = 38^\circ$, $c = 0$, and $\alpha = 36.3^\circ$. The resulting safety factors are shown in figure 20. Thus, only moderate increases in either ϕ or c , or in both ϕ and c , result in computed safety factors indicating stability.

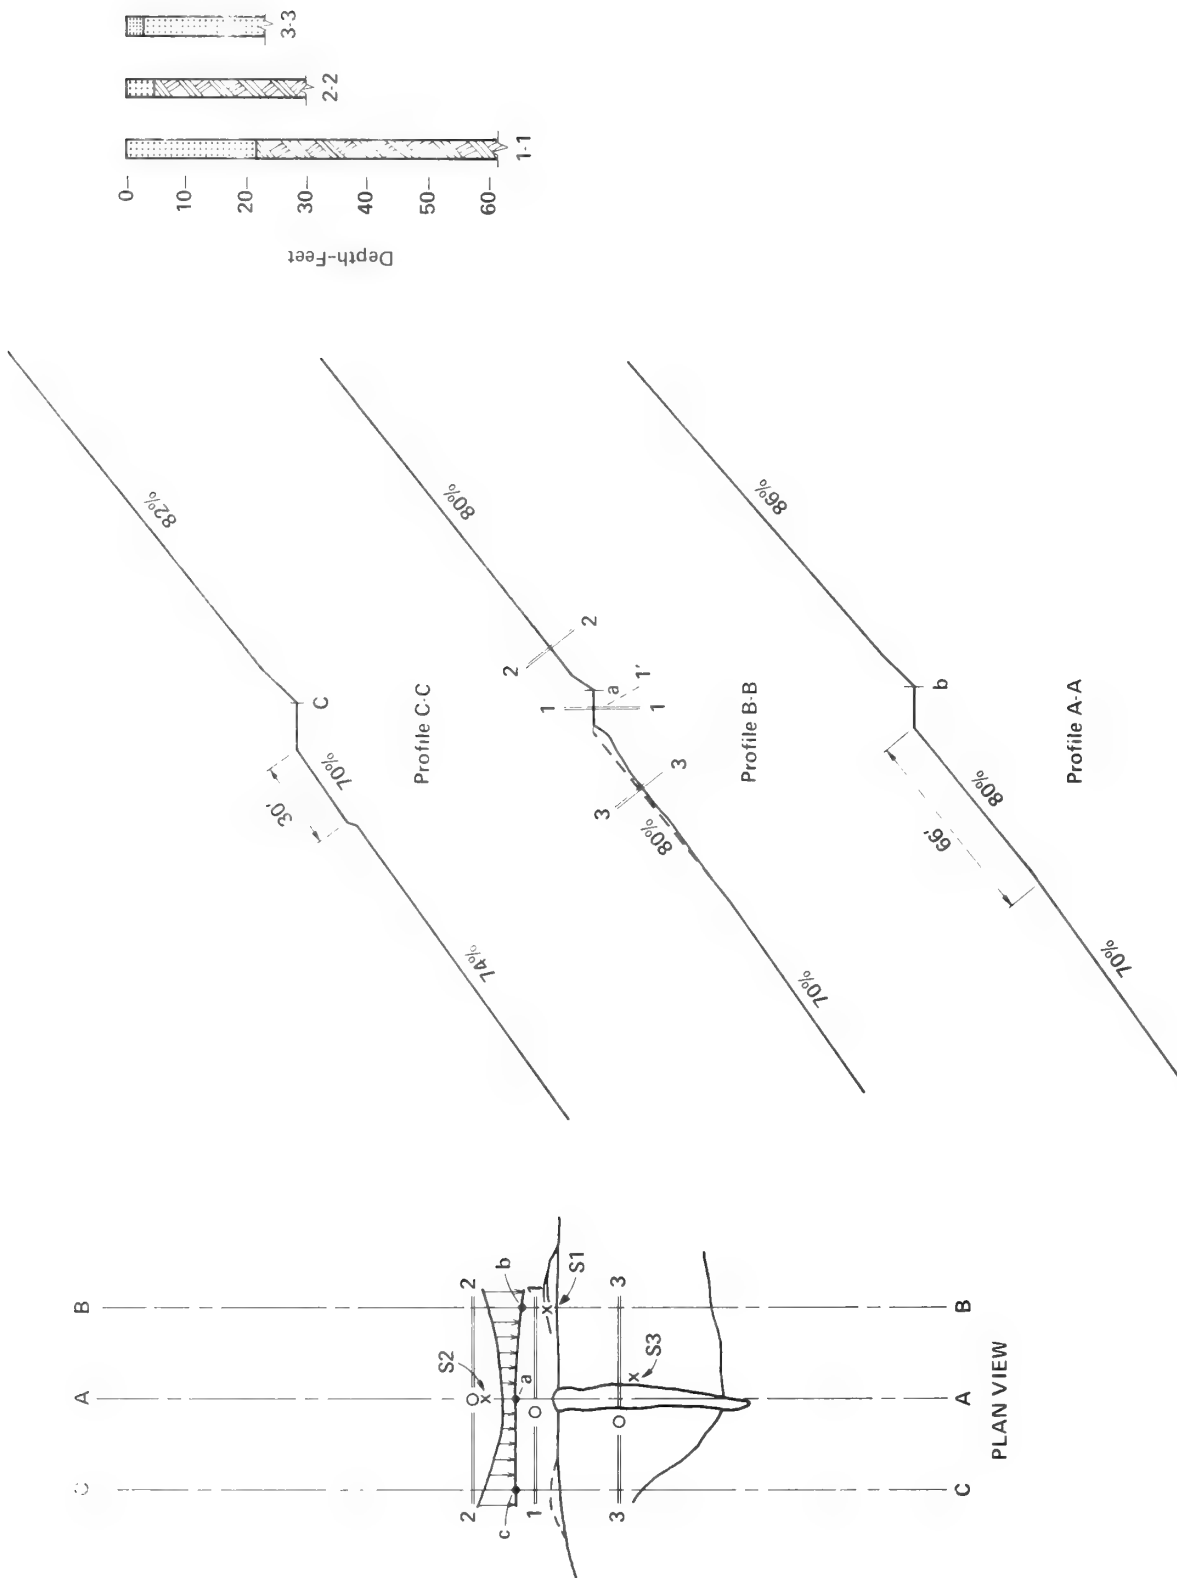
Figure 24.--Description of test site 917-3.

Site 917-3. This site, shown in figures 21-23, is located on Road 917 approximately 4.2 miles from the junction of Road 917 and the main Secesh Road (fig. 4). Considerable importance is placed upon the analysis of this site, primarily because failure is impending, as evidenced by cracking in the road surface and settlement of the outside portion of part of the fill (figs. 21 and 22). In addition, a narrow portion of the fill has failed, as shown in figure 23. Thus, this site offered the best opportunity for material sampling and definition of the mode and shape of failure.

Plan view and profile sketches appear in figure 24, along with pertinent seismic profile and test pit information.

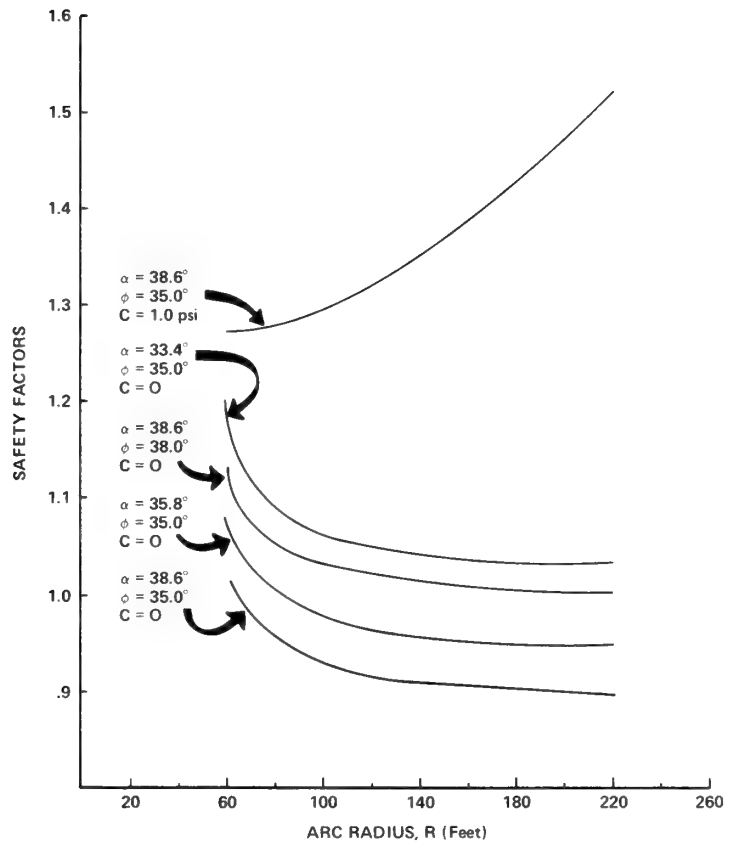
Figure 25.--Safety factors vs. arc radius, R , for site 917-3, with zero boundary neutral stresses.

The results of these analyses are shown in figure 25, wherein R and α are again defined as in figure 17.

Finally, a series of analyses were conducted with ϕ increased to 38° and $c = 0$. The results of these analyses are also shown in figure 25, and seem to be most compatible with the observed conditions at the site.

The low depth-to-length ratio of the failure at this site suggests that the infinite slope stability theory might be applied. Assuming a depth no greater than one-twentieth the length, or about 3.5 feet, developed cohesion values of only 0.18 and 0.03 p.s.i. are necessary for stability in the absence of seepage forces, for $\phi = 35^\circ$

and 38°, respectively. Under the extreme condition that would permit seepage throughout the fill, with a top flow line coincident with the fill slope, the necessary developed cohesion values would be 0.83 and 0.75 p.s.i. for $\phi = 35^\circ$ and 38° , respectively. Such an extreme seepage condition seems unlikely at this site, although it has already been noted that water collected on the road at this location. It is possible, however, that water infiltrating from the road surface combined with the ground water, resulting in emergence of the water at some location above and near the toe of the fill slope. A subsequent "blow out," or quick condition might have occurred locally, and the resultant loss of support at the toe would have allowed the upslope material to slide.

In any case, the analyses of this site and of site 917-1 seem to indicate that a more realistic value for the friction angle in this material might be about 38° .
